Notice to Navigation Interests

Condition of Federal Navigation Channel Sandusky Harbor, Sandusky, Ohio

SANDUSKY HARBOR, OHIO

CHANNEL CONDITIONS
AFTER FALL CONTRACT DREDGING

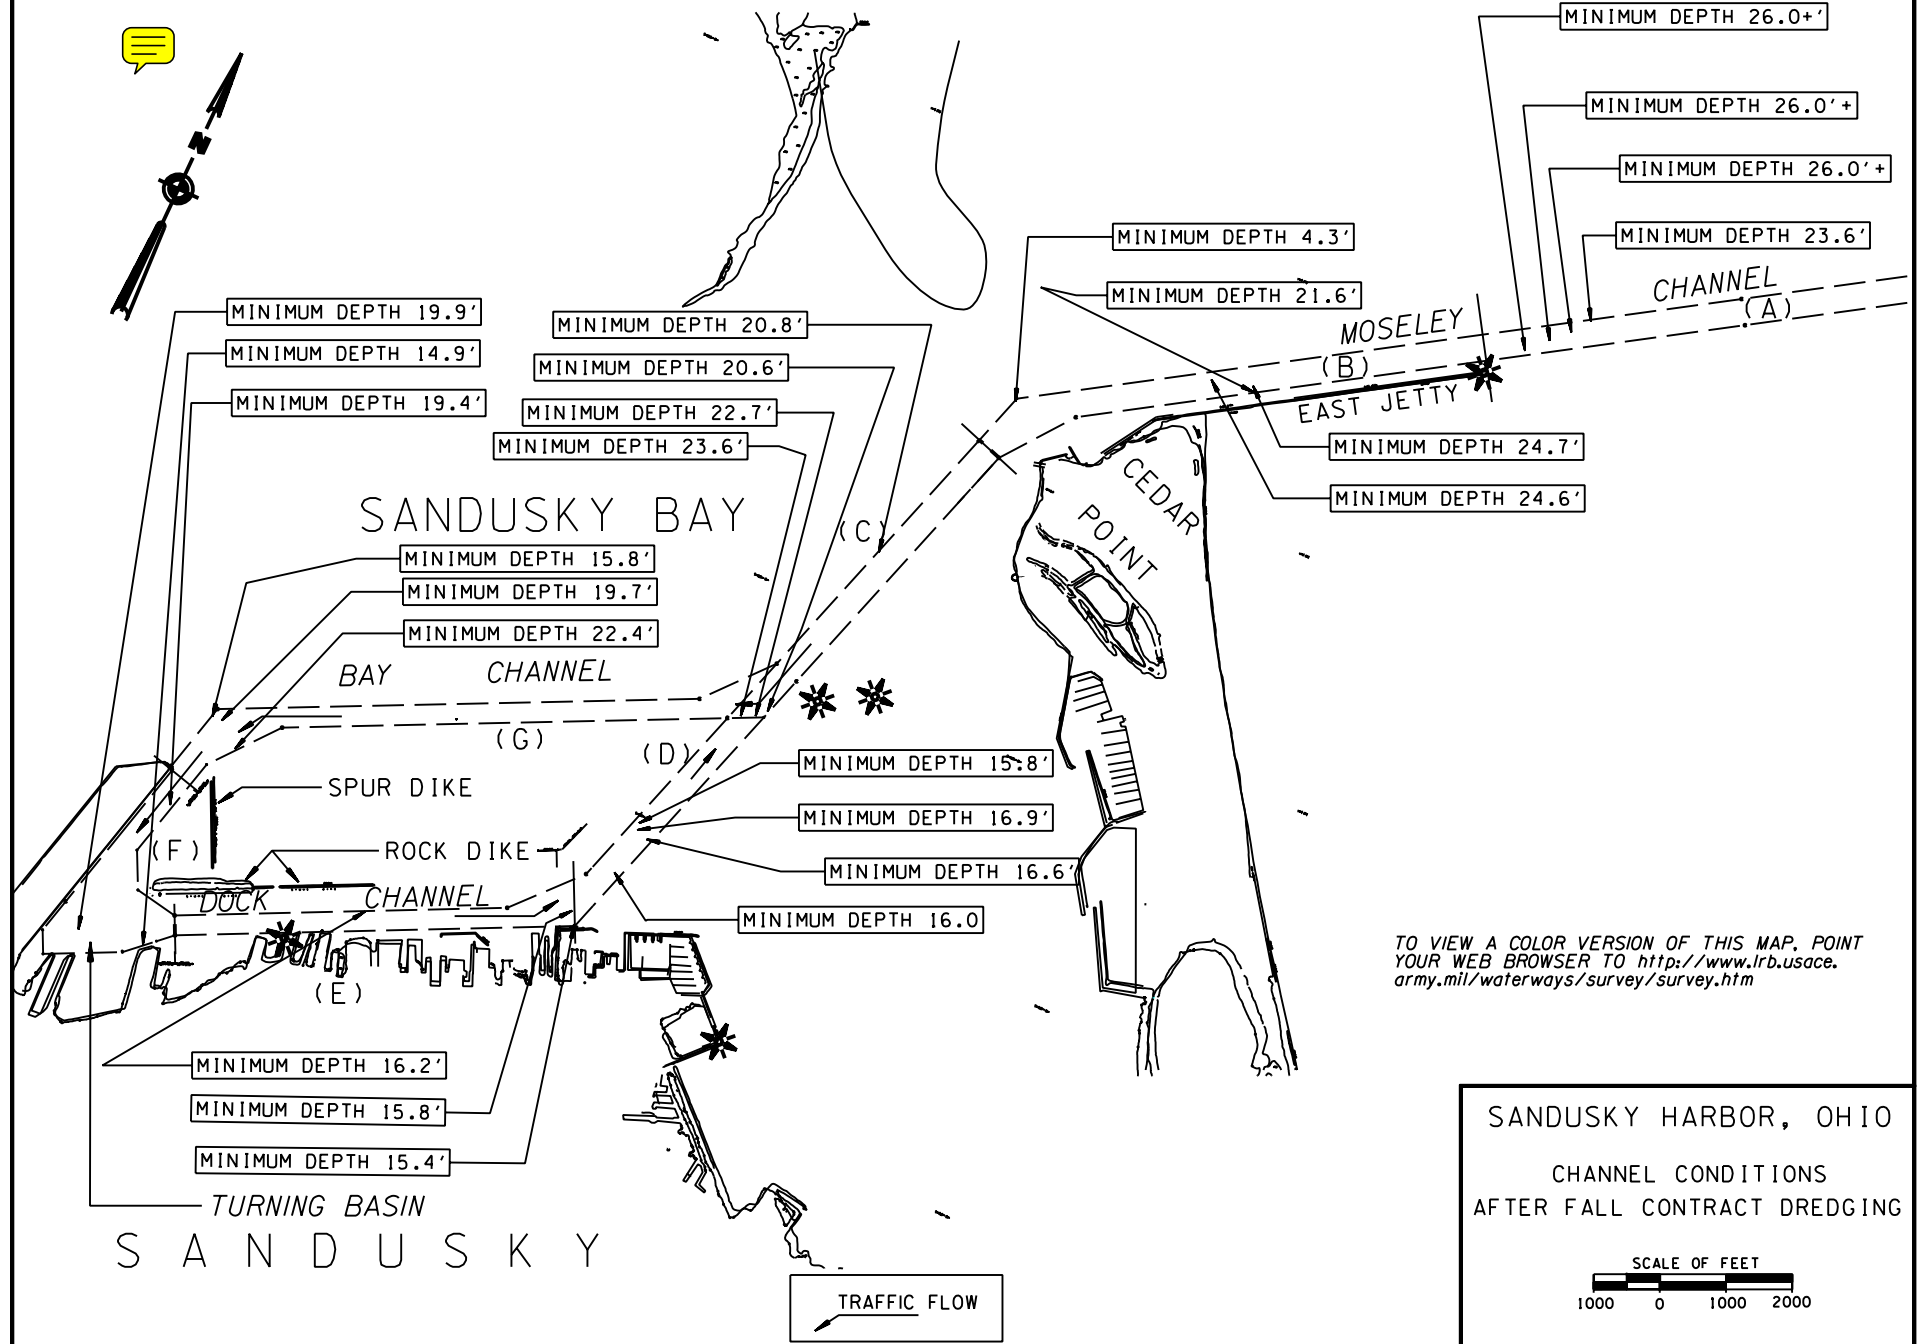
1. Condition surveys performed within the Federal navigation Channel at Sandusky Harbor, Ohio during the month of September 2004 indicate shoaling has reduced depths to those shown on the attached standard tabular form and channel condition drawings.

(A) MOSELEY LAKE APPROACH CHANNEL FROM DEEP WATER TO THE EAST END OF THE EAST JETTY.	SEPT .2004	400	6000 (a)	26	26.0+	26.0+	26.0+	23.6
(B) MOSELEY ENTRANCE CHANNEL FROM THE EAST END OF THE EAST JETTY TO THE OUTER END OF THE STRAIGHT CHANNEL AT THE COAST GUARD STATION.	SEPT .2004	400 (o)	8000	26	21.6	24.7	24.6	4.3

(C) STRAIGHT ENTRANCE CHANNEL FROM INNER END OF MOSELY CHANNEL TO THE INTERSECTION OF THE BAY CHANNEL.	SEPT .2004	400 (o)	5500	25	20.6	22.7	23.6	20.8
(D) STRAIGHT ENTRANCE CHANNEL FROM THE INTERSECTION WITH THE BAY TO THE INTERSECTION WITH THE DOCK CHANNEL.	SEPT .2004	400 (o)	4200	21	15.8	16.9	16.0	16.6

(E) DOCK CHANNEL.	SEPT .2004	300 (o)	5800	22	16.2	15.8	15.4
(F) TURNING BASIN AND COAL DOCK AREA FROM THE WEST END OF THE DOCK CHANNEL TO THE NORTH END OF THE COAL DOCK.	SEPT .2004	300-1500	300-1500 (b)	24	19.4	19.9	14.9

(G) BAY CHANNEL, FROM NORTH END OF COAL DOCK TO THE INTERSECTION WITH THE STRAIGHT CHANNEL.	SEPT .2004	300 (o)	9000	25	22.4	19.7	15.8

3. Vessel operators are advised to use caution when navigating in this area.
4. Copies of the sounding print for Sandusky Ohio consisting of (4) sheets, 04S-SAN-1/1 thru 1/4, at a cost of \$2.50 per sheet will be furnished upon receipt of a check in the full amount made payable to: United States Army Engineer District, Buffalo. Requests should be addressed to: District Commander, U.S. Army Engineer District, Buffalo, ATTN: NY/PA O&M Office, 1776 Niagara Street, Buffalo, New York 14207, requesting exact number or copies of sheets by file number. A point of contact and phone number must be indicated to facilitate response to the request. To obtain the Metadata and CADD files and view a color version of this map, point your web browser to <http://www.lrb.usace.army.mil/waterways/survey/survey.html>. Click on the link "SURVEY SECTION" to send a message containing your request
